**DEPARTMENT OF TRANSPORTATION****DIVISION OF ENGINEERING SERVICES**

Contract #: 04-0120F4Cty: SF/ALA Rte: 80 PM: 13.2/13.9File #: 69.28**WELDING INSPECTION REPORT****Resident Engineer:**Siegenthaler, Peter**Address:** 333 Burma Road**City:** Oakland, CA 94607**Report No:** WIR-024488**Date Inspected:** 07-Jun-2011**Project Name:** SAS Superstructure**OSM Arrival Time:** 700**Prime Contractor:** American Bridge/Fluor Enterprises, a JV**OSM Departure Time:** 1900**Contractor:** Zhenhua Port Machinery Company, Ltd (ZPMC), Changxing Island **Location:** Shanghai, China**CWI Name:** An Qing Xiang**CWI Present:** Yes No**Inspected CWI report:** Yes No N/A**Rod Oven in Use:** Yes No N/A**Electrode to specification:** Yes No N/A**Weld Procedures Followed:** Yes No N/A**Qualified Welders:** Yes No N/A**Verified Joint Fit-up:** Yes No N/A**Approved Drawings:** Yes No N/A**Approved WPS:** Yes No N/A**Delayed / Cancelled:** Yes No N/A**Bridge No:** 34-0006**Component:** OBG Components**Summary of Items Observed:**

**Outside Yard – OBG Trial Assembly**

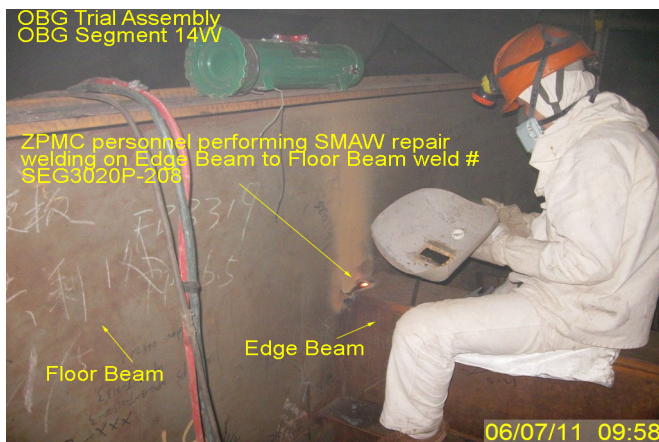
This QA Inspector observed ZPMC qualified welding personnel identified as 069118 perform repair welding by Shielded Metal Arc Welding (SMAW), on Edge beam to Floor beam weld at panel point 126.5 of OBG Segment 14W. Weld joint is identified as SEG3020P-208. ZPMC Quality Control (QC) Inspector identified as An Qing Xiang was present to monitor the welding process. The welding variables recorded by ZPMC QC appeared to be in general compliance with WPS-345-SMAW-1G-FCM-Repair-1, which is used as per Welding repair report B-WR20970. See attached picture.

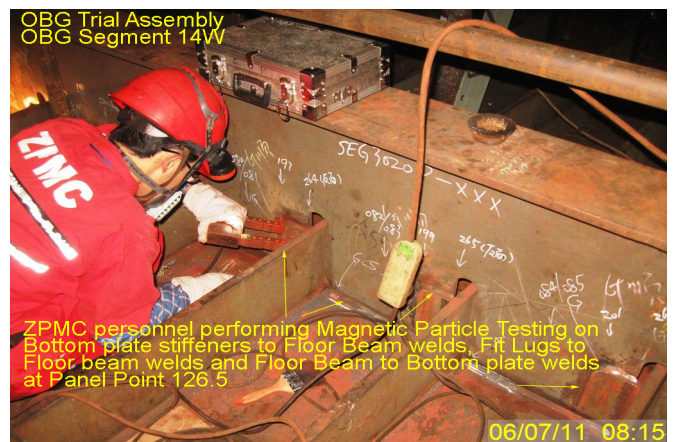
This QA Inspector observed ZPMC qualified NDT personnel perform Magnetic Particle Testing on Bottom plate I Rib stiffeners to Floor beam welds, Fit Lugs to Floor beam welds and Floor beam to Bottom plate welds at panel point 126.5 of OBG Segment 14W. See attached picture.
